Name Of Dam: LAKE BRITTLE DAM

Location: FAUQUIER COUNTY

Inventory Number: 06122

# PHASE I INSPECTION REPORT NATIONAL DAM SAFETY PROGRAM

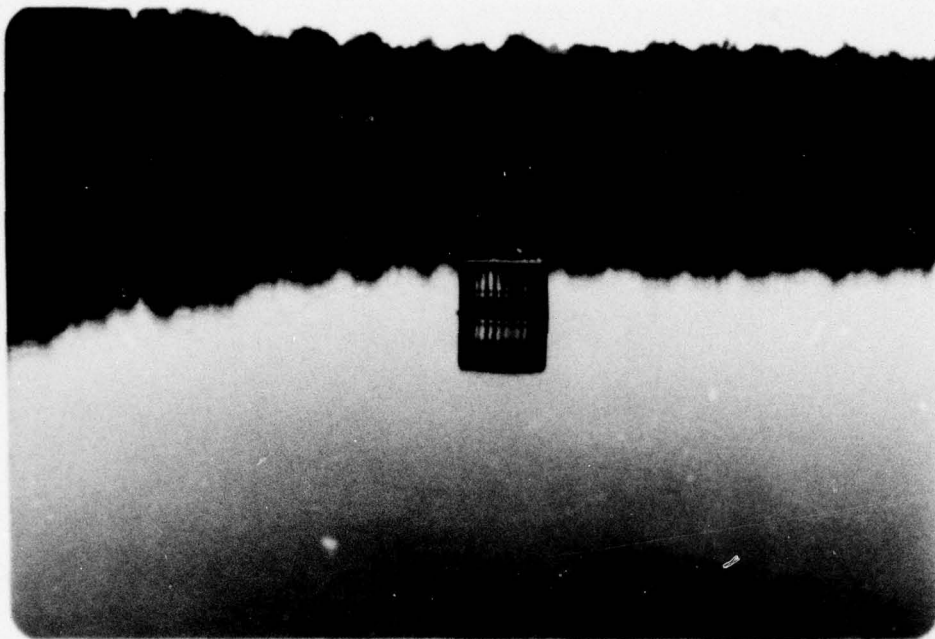
PHOTO #1 INTAKE STRUCTURE

3.1.3 Appurtenant Structures: Observations of the intake structure showed deterioration. However, most of the structure was submerged at the time of the inspection, Appendix II, Photo 1. The principal spillway and discharge channel appeared to be in good condition and showed no signs of deterioration, Appendix II, Photo 2.

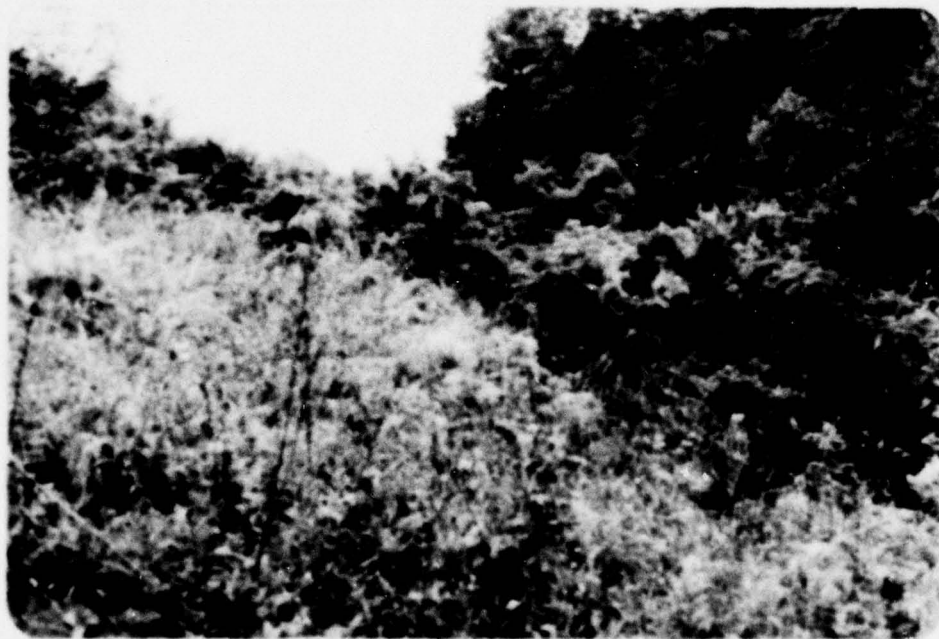
PHOTO \* 6 HEAVY VEGETATIVE GROWTH  
ON DOWNSTREAM SLOPE

- a. Trim all brush and locust located on the embankment.
- b. Repair the small erosion gully in the upper portion of the discharge channel of the emergency spillway.
